Rehabilitation of right central incisor after traumatic root fracture

Dr. Nuno Rocha Jorge, Private Clinic, Portugal

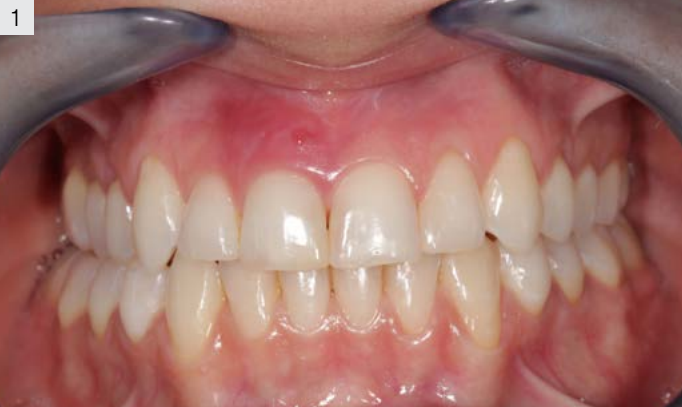
Horizontal fracture on tooth 11.
There is a noticeable fistula.

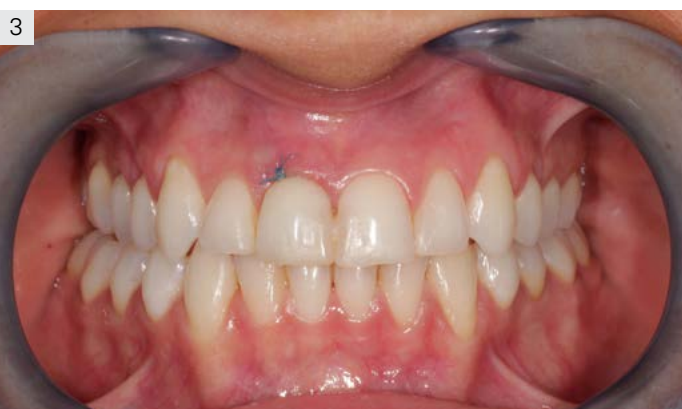
Alveolar bone preservation with
xenograft, and a free gingival graft
with the fractured tooth, bonded to the
adjacent tooth.

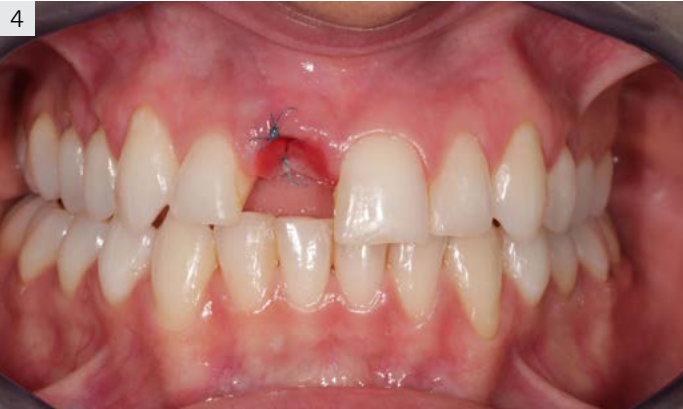
4 months after alveolar bone preservation. 6/0 monofilament sutures were kept in place due to the distance of the patient's residence from the clinic.

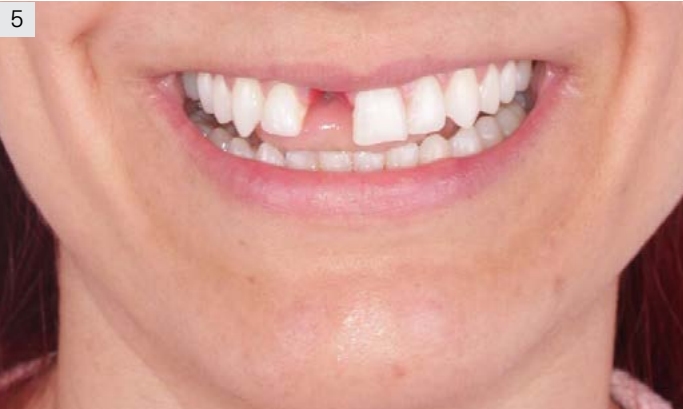
5

Frontal view.

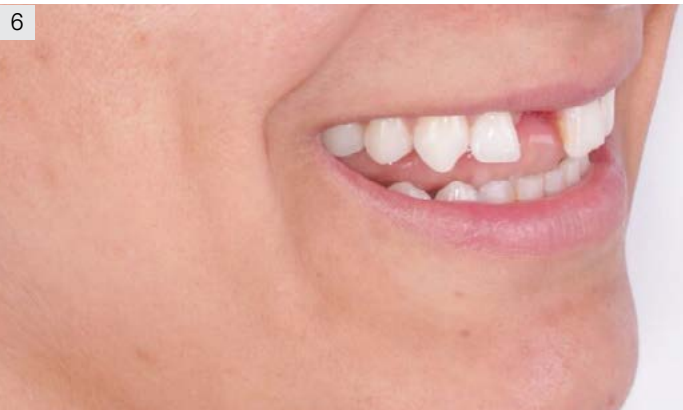
6

Lateral view.

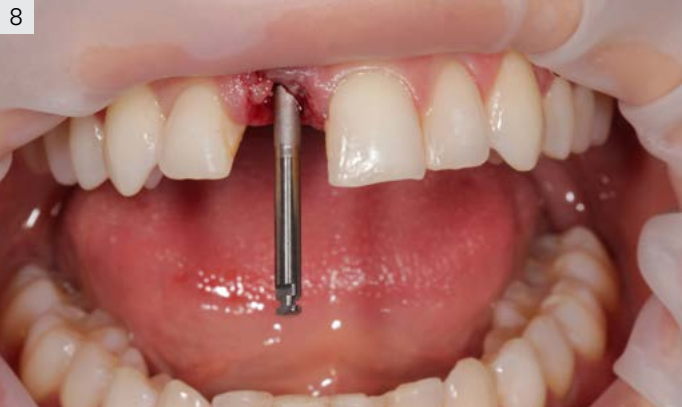
Checking of correct drilling direction.

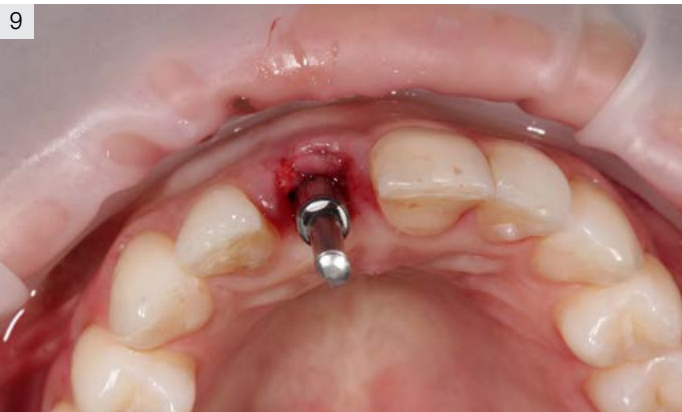
C1 Implant installation.
(C1- 3,75x13 mm)

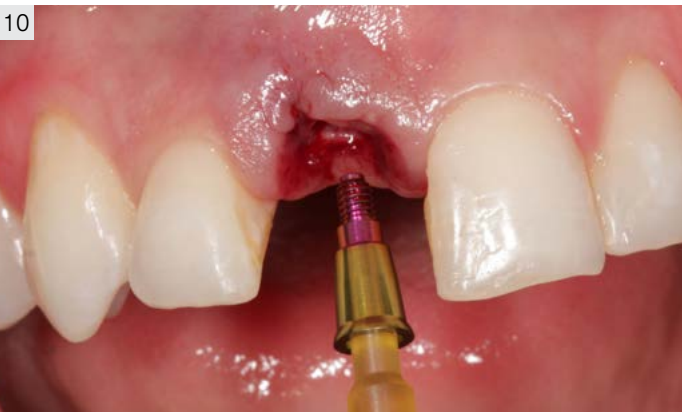
CONNECT abutment installation.

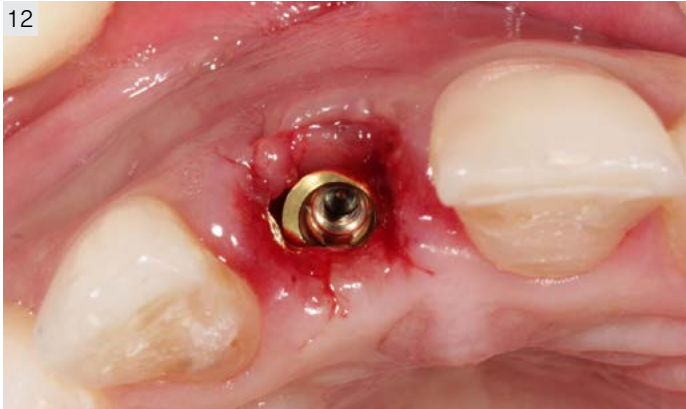
CONNECT abutment in place with connective tissue graft.

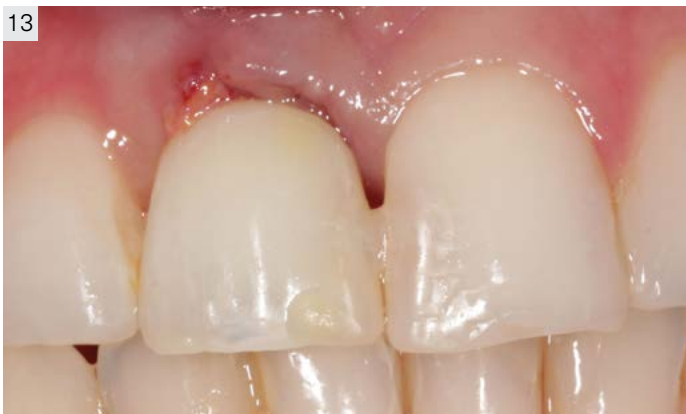
Temporization with only one suture to hold the connective tissue graft in the desired location.

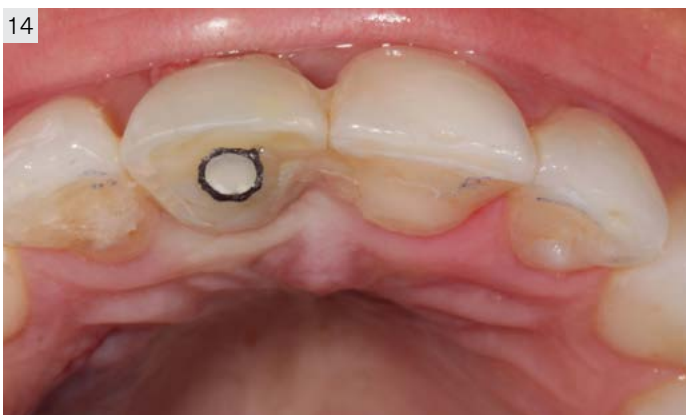
Occlusal view.

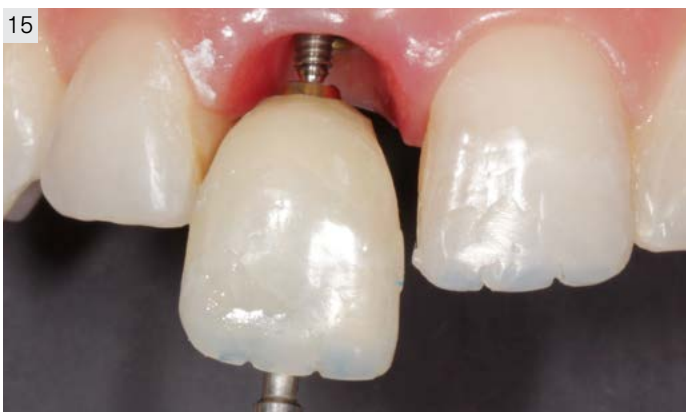
4 months postoperative. Removal of temporary restoration.

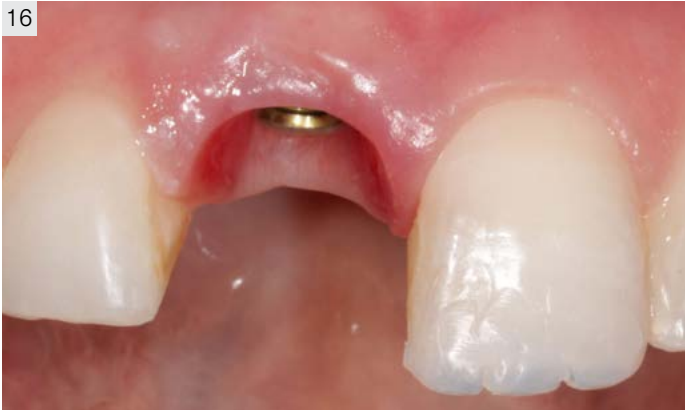
16

4 months postoperative tissue profile.

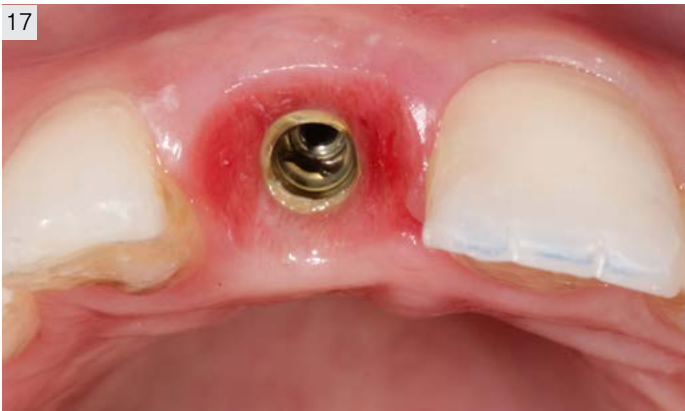
17

4 months postoperative tissue profile.

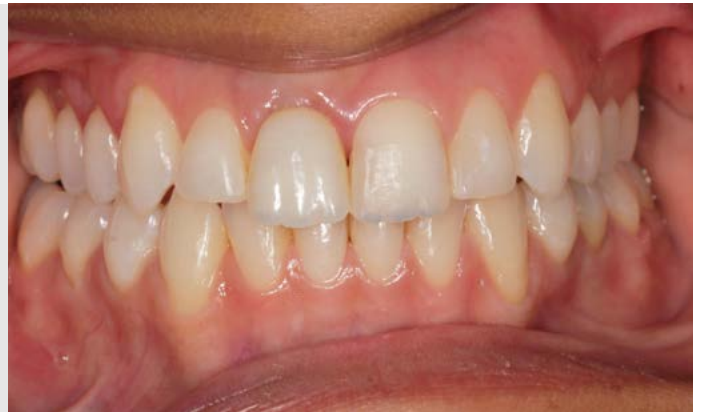
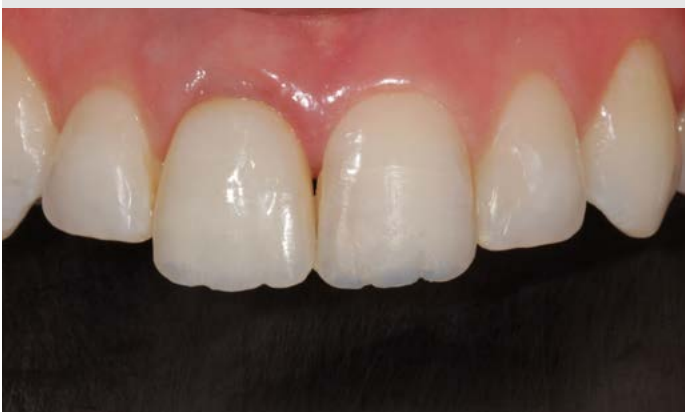
18

Final restoration.
